***BRENCO* – NBC**

POCKET MANUAL

FIELD INSPECTION OF CARTRIDGE TAPERED ROLLER BEARINGS

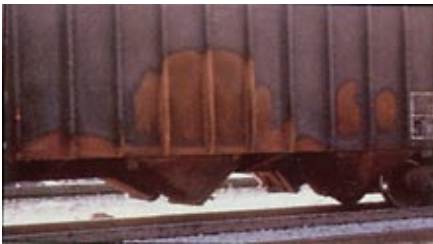
Fig. 3 : Car body showing heat damages.

Fig. 3-5 illustrates heat damages on the car-side, side-frame, bearing end cap, adapter and wheel. Excessive heat cause damaged grease seals, burnt grease & metallurgical properties are totally destroyed.

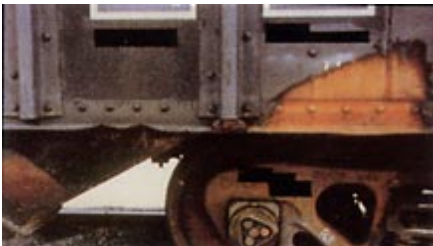
Fig. 4 : Burned side frame, adapter, bearing and car body.

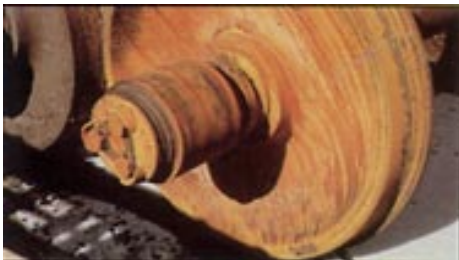
Fig. 5 : Wheel & bearing assembly showing evidence of excessive heat.

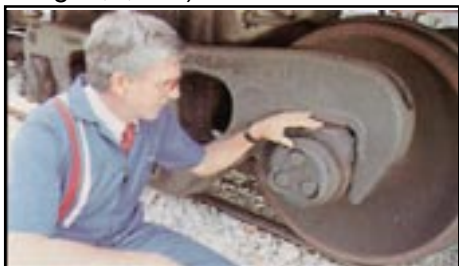
Fig.6 : Adapter properly positioned in side frame

becomes displaced from its correct location on the cup, then mechanical damage, off-center loading, accelerated fatigue damage and premature bearing failure can result. Replace worn-out adapters and correct the position of displaced adapter immediately (Refer Fig. 6,7, & 8).

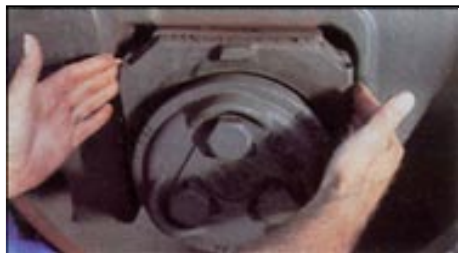
Fig.7 : Adapter properly located on bearing cup

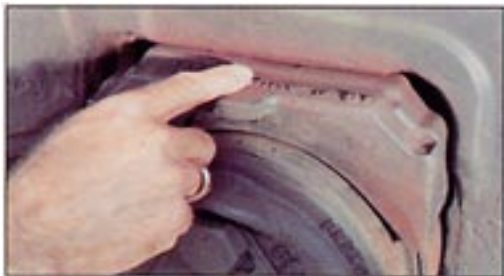
Fig. 8 : Adapter crown (cast) relief area

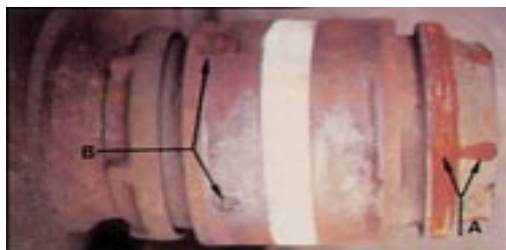
Fig. 9 : Adapter has been displaced to outboard end of bearing. Thrust shoulders has been riding on the end cap flange and rim (A) and has also been point loading the outer race at two points (B)

- (iii) Inspect bearing components for any mechanical damage caused by displaced adapters. Many times adapter related damages are difficult to detect as adapters can return to their normal position during service. Some of the external damages on the bearing of the adapter having been displaced are illustrated in Fig. 9 to 13.

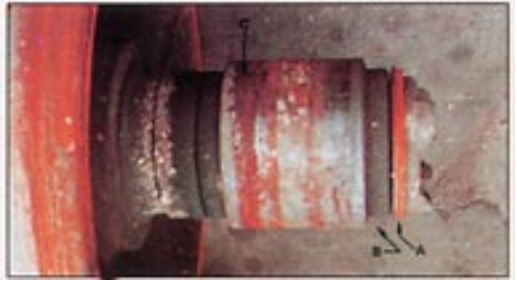
Fig. 10 : Adapter has been displaced to outboard end of bearing. Thrust shoulders has worn away the end cap rim (A) and has displaced the outboard seal (B). Inboard thrust shoulder has been riding on the outer race over the inboard load zone

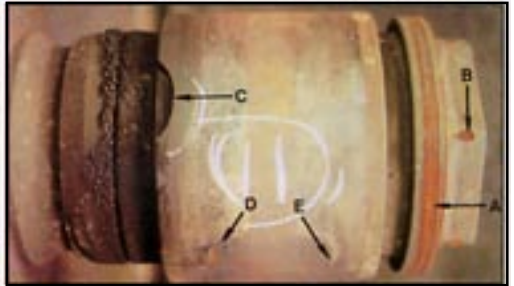
Fig. 11: Adapter has been displaced to outboard end of bearing. Thrust shoulders have been in contact with end cap flange (A) and rim (B) have broken the cup counter bore (C). At one time the adapter was also correctly positioned as indicated by contact patterns on cup outside diameter.

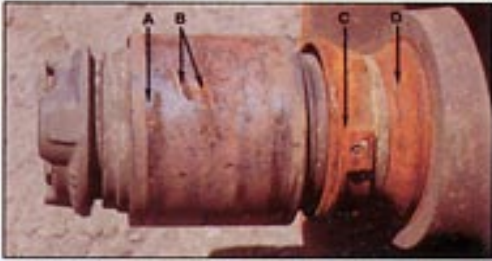
Fig. 12: Adapter has been displaced to inboard end of bearing. Adapter thrust shoulders have been in contact with outer race over the load zone outboard (A & B) and with the backing ring and journal fillet radius inboard (C & D) indicating multiple displacements.

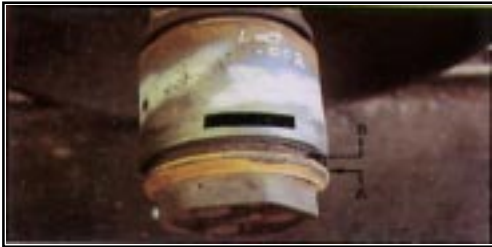
Fig 13: Adapter has been displaced to outboard end of bearing and has cut away the end cap flange (A) and grease seal case (B). This condition would require inspection from the side of the bearing to be detected. Inspection from the end of the bearing would not reveal the damage.

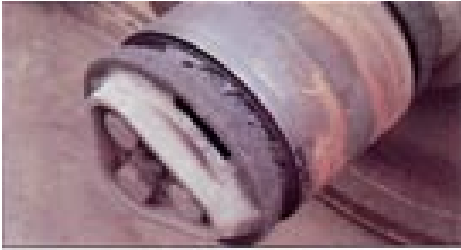
Fig.14: Grease leaking between cup counter bore and grease seal case

- (i) Grease leakage between cup counter bore and seal outside diameter may be an indication of loose seal. Use suitable probe or a screw driver to check if the Seal is loose in cup counter bore (Fig. 14 & 15). Bearing having loose grease seals must be removed from the service, and sent for re-conditioning.

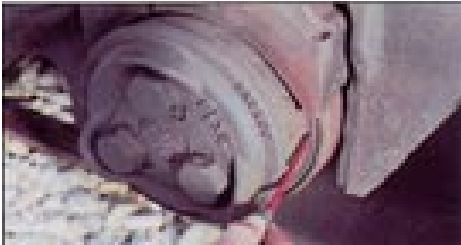
Fig. 15 : Probing for a loose grease seal

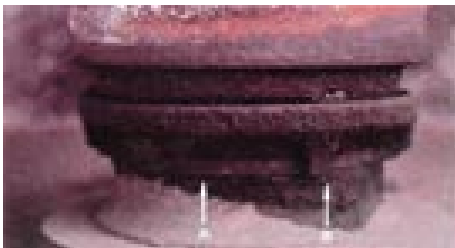
Fig. 16 : Grease leaking between backing ring and journal fillet radius

- (ii) Grease leaking between the backing ring and axle fillet radius is an indicator of loose backing ring. Bearings with loose backing ring must be removed from service and sent for re-conditioning (Fig. 16).

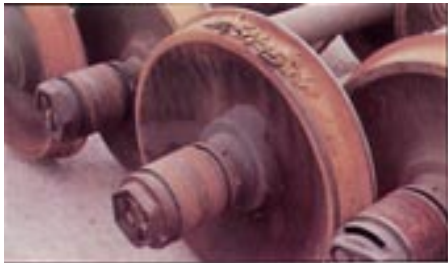
Fig. 17 : Built up treads

Wheel conditions which can generate high impact forces into the bearing are indicators of possible internal damage. Built up tread and several slid flats are two such conditions, which can be detrimental to the bearings (Refer Fig.17 & 18).

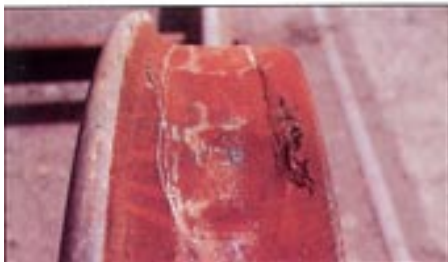
Fig. 18 : Slid - flat tread

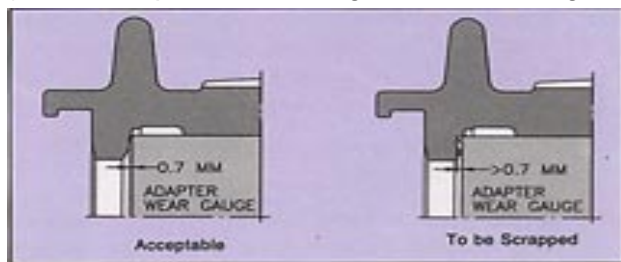
Fig. 23 : Checking Wear of Thrust Shoulder Faces

- (i) Cracked or broken adapters must be scrapped. Repair by weld or brazing is not permitted.
- (ii) Warped, twisted or distorted adapters must be scrapped. To check this, place the adapter on cup and it must seat firmly on the bearing cup without rocking or pinching when hand pressure is applied.
- (iii) Adapters worn to the extent that ridges / grooves prevent proper seating in the side frame or over the cup, must be scrapped.
- (iv) If the crown on the adapter top has worn out to such a condition that side frame would bear on crown relief portion, adapter must be scrapped.
- (v) Thrust shoulder of the adapter may show wear due to contact of cup face. If depth of such groove exceed 0.7 mm at any location adapter must be scrapped (use of Adapter Wear Gauge is shown in Fig. 23).

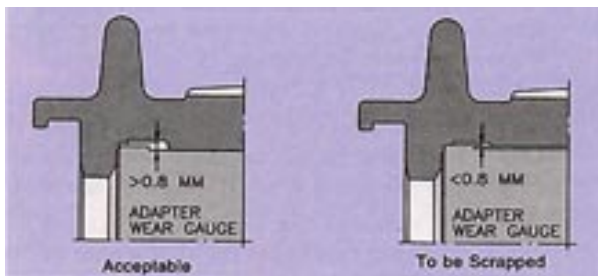
- (vi) Adapters having depth of machined relief less than 1/32" (0.8mm) when checked by 'Adapter Wear Gauge' must be scrapped (Refer Fig. 24).

Fig. 24 : Checking Wear of Bearing Seat Areas

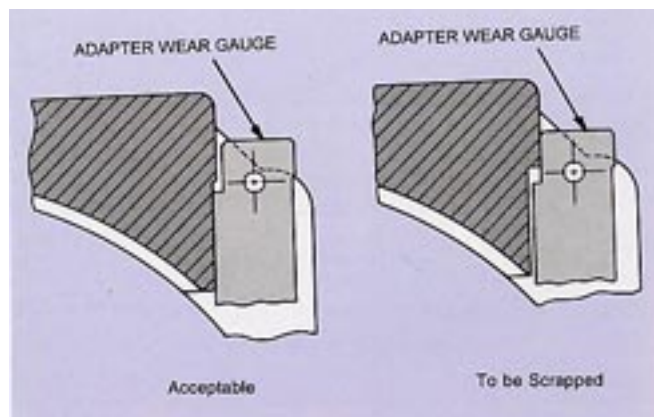
Fig. 26-27 : Checking Adapter Body Wear

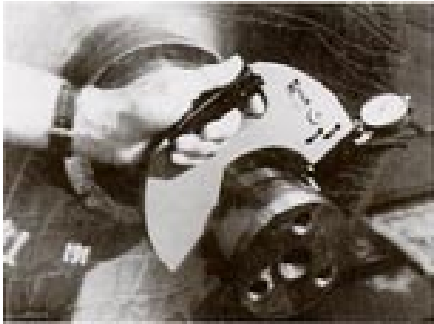
Fig. 28 : Use of Dial snap gauge

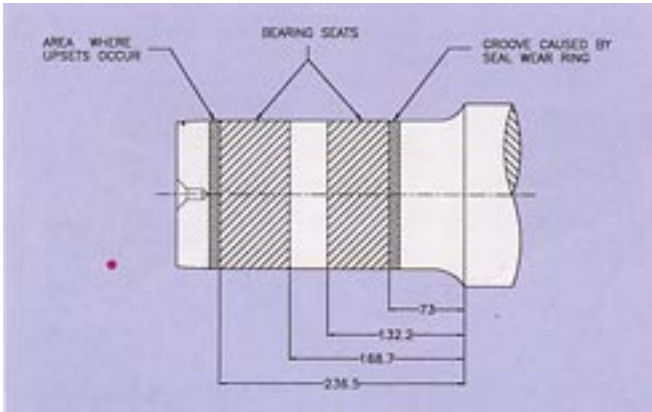
Fig 29 : Locations of Bearing seat Areas, Wear Ring groove and upset ends on 6 x 11 journal. **BRENCO-NBC**

The inboard wear ring can cause a groove on the journal due to axle flexure. Refer Fig.29 showing location of the groove. If the groove in the axle is not deeper than 0.002" (0.05 mm), it can be repaired by polishing with an abrasive cloth (80 grit or finer). No abrupt changes or sharp edges / are permissible.

Area where upsetting of the journal occurs is shown in Fig. 29. Dial or Digital snap gauge must be rotated by 180 degrees around the area where upsets occur. In order for a journal to be acceptable, the diameter in the area where upsets occur must never exceed 0.003" (0.08 mm) above maximum tolerance but may be below the minimum tolerance. Upset ends over 0.003" (0.08 mm) may be corrected.
